APOLLO 15 MISSION REPORT

MANNED SPACECRAFT CENTER  
HOUSTON, TEXAS  
DECEMBER 1971

Mission Evaluation Team

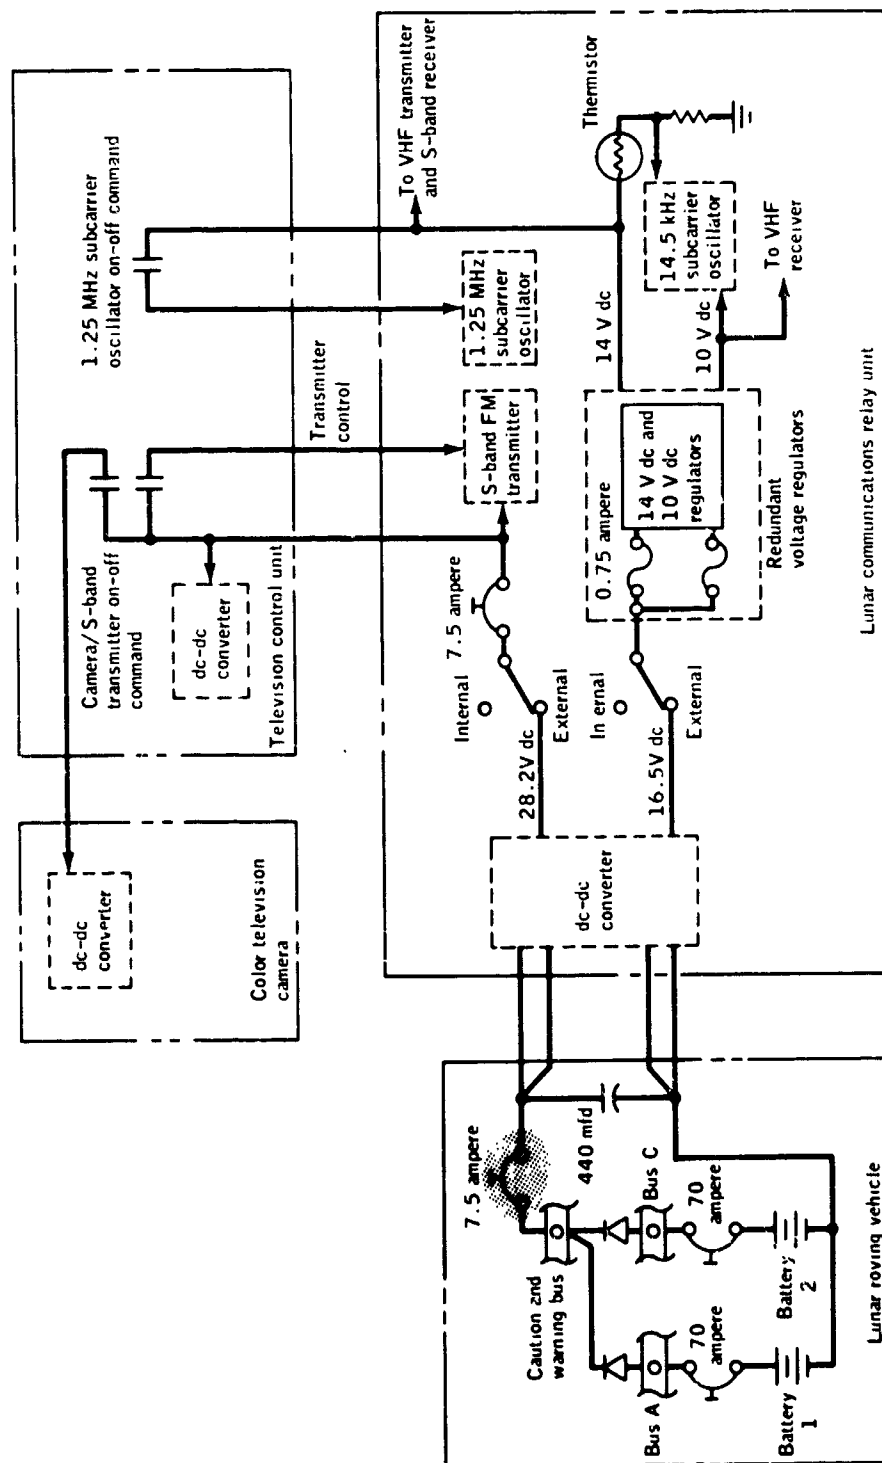
Figure 14-48.- Lunar roving vehicle/lunar communications relay unit/ground controlled television assembly power distribution.

In laboratory tests, the fault which duplicated the flight data was the opening of the lunar roving vehicle power line prior to the 440-microfarad capacitor (figs. 14-48 and 14-49). The tests show that the decay time of the lunar communications relay unit 28-volt and 14-volt power is increased by discharging the 440-microfarad capacitor. Other induced faults resulted in shorter power decay times, affecting the received signal accordingly. The temperature measurement output (see thermistor in fig. 14-48) is proportional to the decay in 14-volt power. Consequently, the 6-percent decay of the flight temperature measurement corresponds to a 1.4-volt decay. This characteristic was duplicated when the lunar roving vehicle power line was opened. The 28-volt power decayed to 21.8 volts dc as the 14-volt power decayed to 12.6 volts. The RF transmitter power at this voltage will be decreased by 6.4 dB, and accounts for the total signal loss at this time since the ground receiver would be below its operating threshold.

The lunar roving vehicle power line has a 7.5-ampere circuit breaker forward of the 440-microfarad capacitor (fig. 14-48). Testing a 7.5-ampere circuit breaker under elevated temperatures (180° F) and at vacuum conditions showed that the current capacity is also dependent on the connecting wire size because the wire provides a heat sink to the circuit breaker thermal element. The rover 7.5-ampere breaker used 20-gage connecting wire. Test results show that the breaker, with 20-gage connecting wire, at elevated temperatures and under vacuum conditions, will trip at 3.3 amperes. This corresponds to the calculated lunar communication relay unit load at the time of power failure.

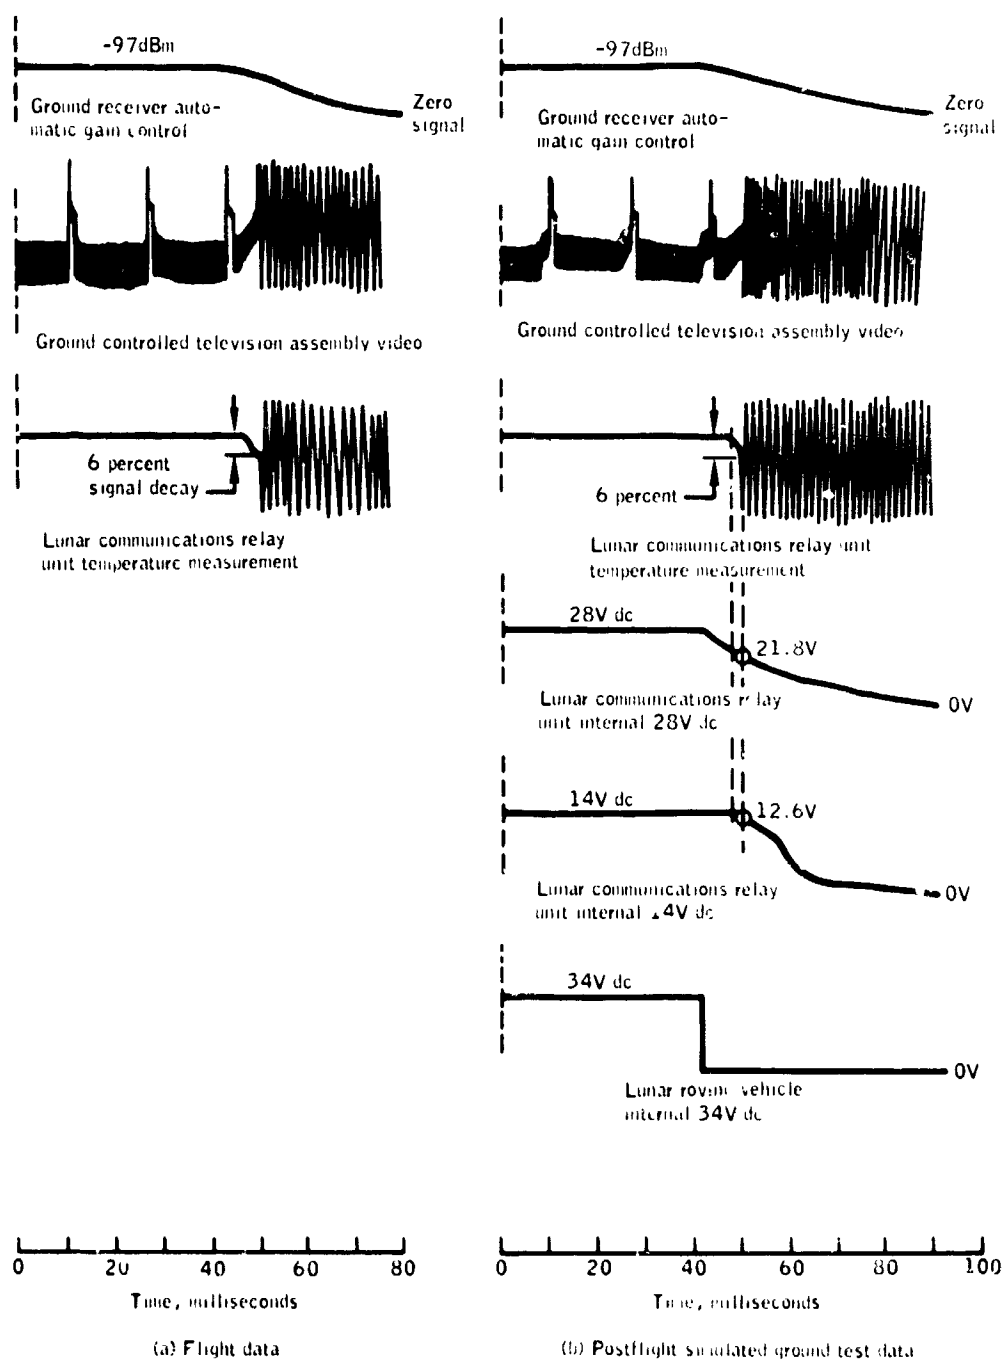
Figure 14-49.- Comparison of signal deterioration characteristics.

The flight data (fig. 14-49) shows that the automatic gain control measurement began to fall followed by the video signal decay. This was followed by the decay of the lunar communications relay unit temperature measurement. The RF signal level then decreased below the ground receiver's threshold as indicated by complete signal loss. The overall loss of the downlink signal within 5 milliseconds is indicative of 28-volt d-c power loss. Decay of the temperature measurement is indicative of 16.5-volt d-c power loss. The lunar communications relay unit dc-to-dc converter (fig. 14-48) supplies both the 28-volt and 16.5-volt d-c power. To verify loss of 16.5-volt power, an uplink voice signal was transmitted to key the VHF transmitter on. No signal was received on the Stanford

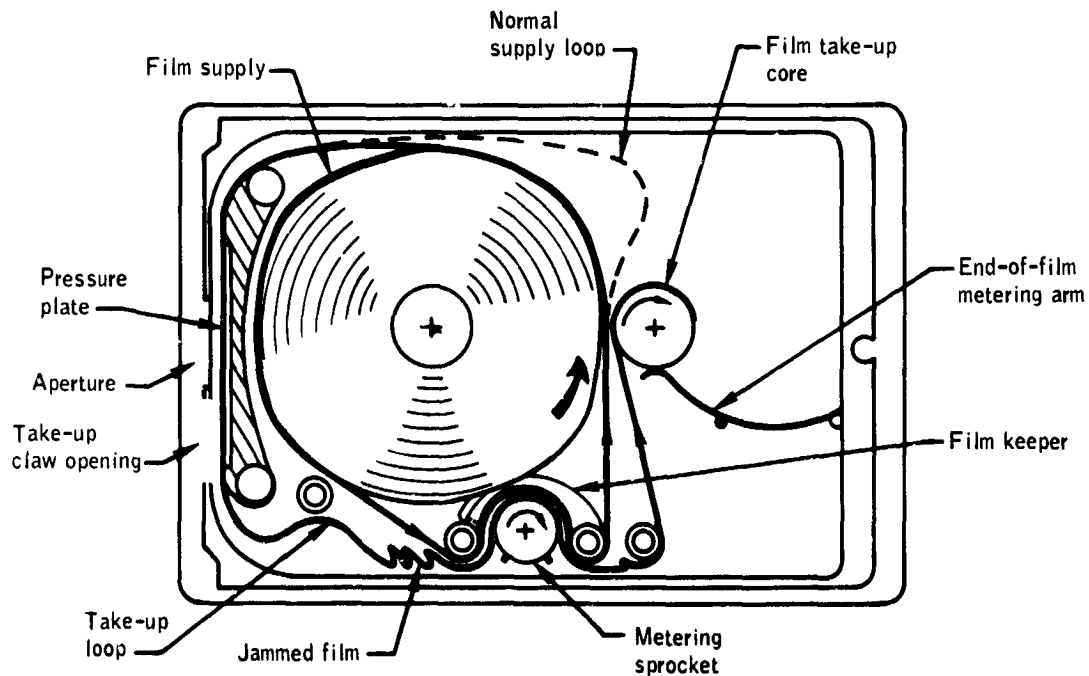
Figure 14-50.- Lunar surface 16mm camera magazine.

a. The first magazine used had drive-spline damage and scratches on the front face, indicating that the installation in the camera was improper and that the magazine and camera were misaligned. Misalignment of the floating female spline of the camera with the male spline of the magazine caused metal to be removed from the brass male spline. In normal camera operation, the take-up claw advances one frame of film for each exposure while the metering sprocket replenishes the supply loop and removes a frame from the take-up loop, thus retaining the same amount of slack film in both loops. When the metering sprocket is not driven because of mis-mating, the camera claw removes film from the supply loop, which is not being replenished, and adds it to the take-up loop, resulting in the jammed condition shown in figure 14-50. Two other magazines had damaged drive

splines, indicating that mismating occurred on at least three occasions. Lunar surface pictures which include the 16-mm camera show that a strip of tape that is installed for latch stowage protection was not removed prior to installation of a magazine. Leaving the tape strip in place could have contributed to the camera/magazine mismating.

b. During troubleshooting between extravehicular activities, the crew manually advanced the film through the aperture in all remaining magazines. The amount of manual advancement varied from five to twenty-one frames in the jammed magazines. The film supply loop (fig. 14-50) normally contains three to five excess frames. The normal procedure is to inspect the magazine for proper frame alignment in the aperture area, and manually advance the film not more than one frame, if required to obtain proper alignment. The excessive manual advancement depleted the film supply loops in all magazines.

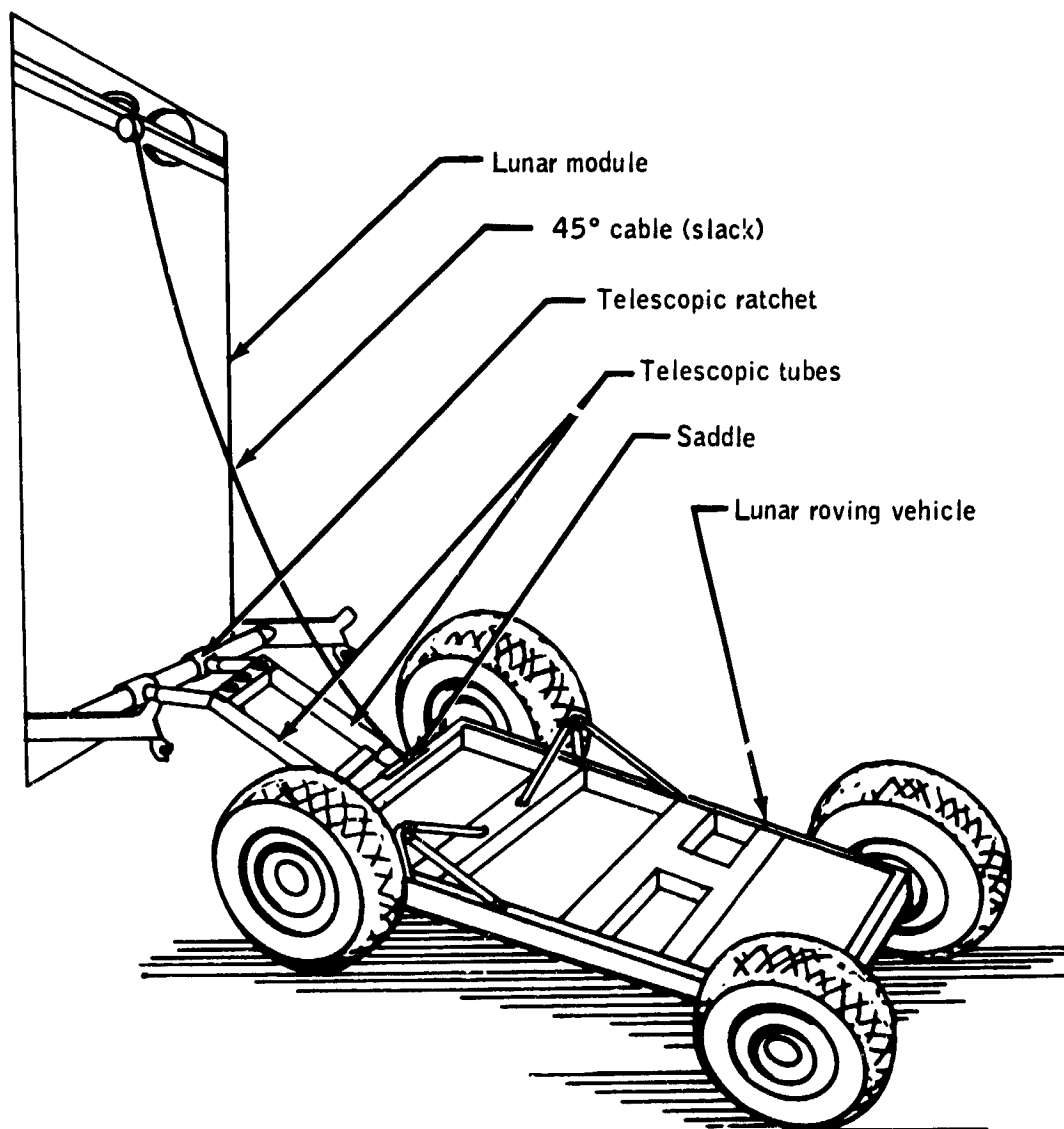
Figure 14-55.- Lunar roving vehicle deployment.

Ground tests have shown that if the partially deployed lunar roving vehicle resting on the surface but not yet detached from the saddle (figure 14-55) and lunar module, is rolled either to the left or right, the saddle/rover chassis interface will bind. The interface can be released, and the saddle dropped to the ground by one crewman adjusting the roll back to zero while the other taps the saddle with a hand tool. The corrective action is to insure adequate crew training.

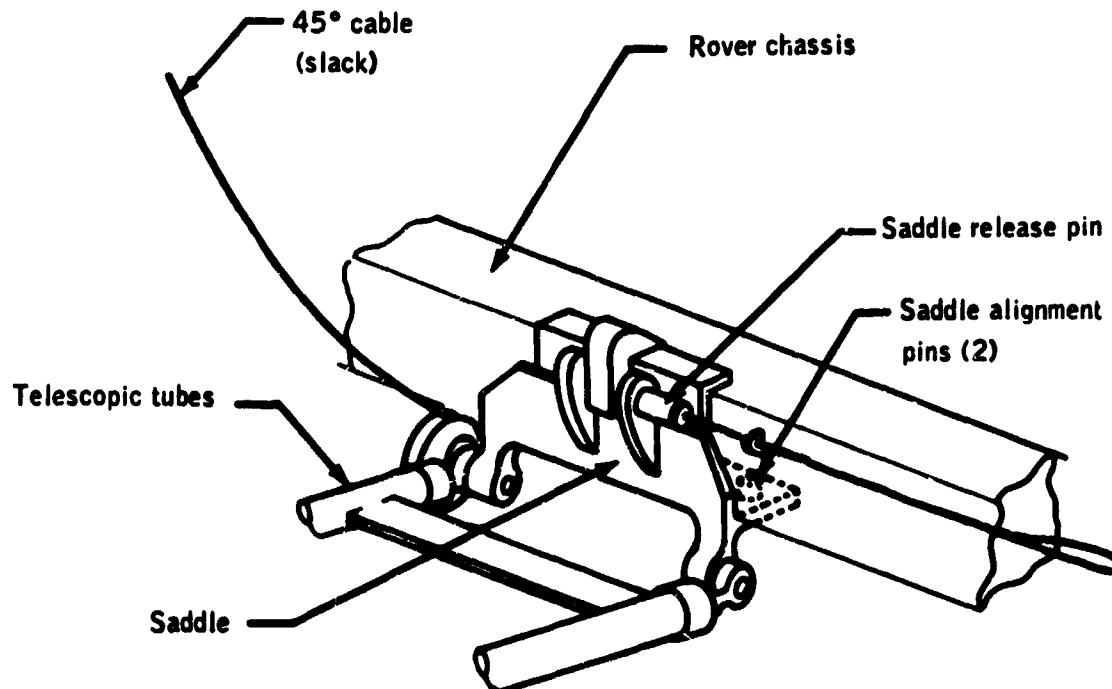
Figure 14-54.- Saddle/lunar roving vehicle interface.

The causes of this problem are twofold and interrelated.

a. The saddle-to-vehicle connection (fig. 14-54) has close-tolerance interfaces to provide the rigidity required to prevent release-pin distortion and permanent binding. This design requires the vehicle/saddle interface to be completely free of stress to permit easy separation.

b. The tilt of the lunar module to the rear and sideways, together with an uneven lunar surface, provided some stress preloading of the vehicle/saddle interface. Attempts by the crew to improve the rover position by moving and pulling on it may have aggravated this situation. The crew was aware that the interface had to be free of stress, and when this was accomplished, the saddle separated.
